# Manhole Inspection Summary

Manhole # S53O\_\_056MH

Insp Date: **4/17/08 8:27 AM**

**Location** Address: **3038 elliott street**

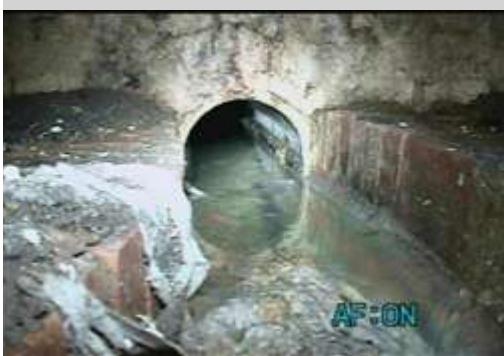
Defect 2

Condition: ☐ Sound ☐ Cracked ☐ Root Intrusion ☐ Deteriorated ☐ Leaks ☒ **Debris**

channel cond debris

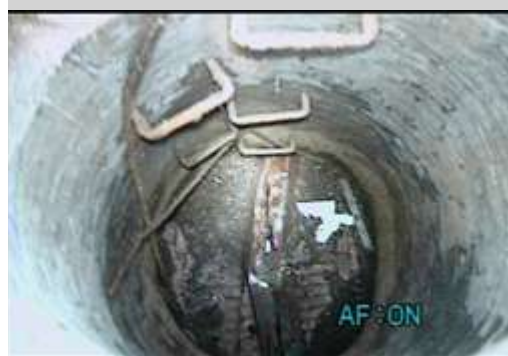
Defect 1

Count: **6** Missing: **0** ☒ **Corroded**

steps

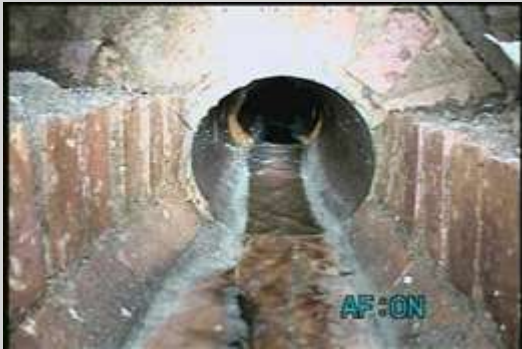
12 O'Clock Outflow

8 in. Circular Gravity Sewer  
Pipe Out @ 12 O'Clock

Pipe Material: **Clay** ☐ Pipe Lined

Invert Depth: **10.60** (ft.) Flow Characteristics: **Slow**

Deposits: ☒ None ☐ Mud ☐ Sludge ☐ Debris ☐ Grease

Infiltration: **None** Pipe Seal Cond: **Unknown**

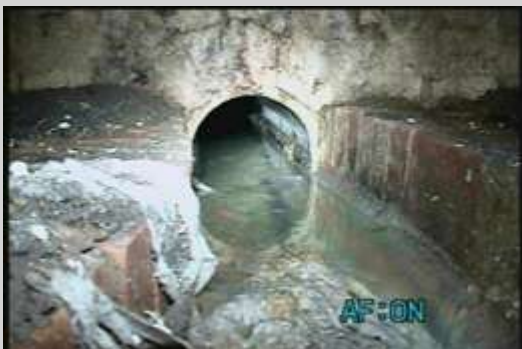
6 O'Clock Inflow

8 in. Circular Gravity Sewer  
Pipe In @ 6 O'Clock

Pipe Material: **Clay** ☐ Pipe Lined

Invert Depth: **10.50** (ft.) Flow Characteristics: **Slow**

Deposits: ☒ None ☐ Mud ☐ Sludge ☐ Debris ☐ Grease

Infiltration: **None** Pipe Seal Cond: **Unknown**
